# BALCONY REPAIR AND REPLACEMENT CASE STUDY

Tiered steel framed with concrete deck balconies of a condominium complex constructed in the 1940's with balconies constructed in 1975 in Virginia were observed to be deteriorated due to corrosion and freeze-thaw effects. TCE was contracted to document the extent of deterioration, perform a structural analysis of the present conditions to determine adequacy, develop a program outlining several repair options for the Homeowners Association, assist in the project bidding process, and provide quality assurance and construction administration services during construction. A cost-benefit analysis determined full replacement of the existing balconies with new, coated aluminum prefabricated balconies would be the best option for the complex.

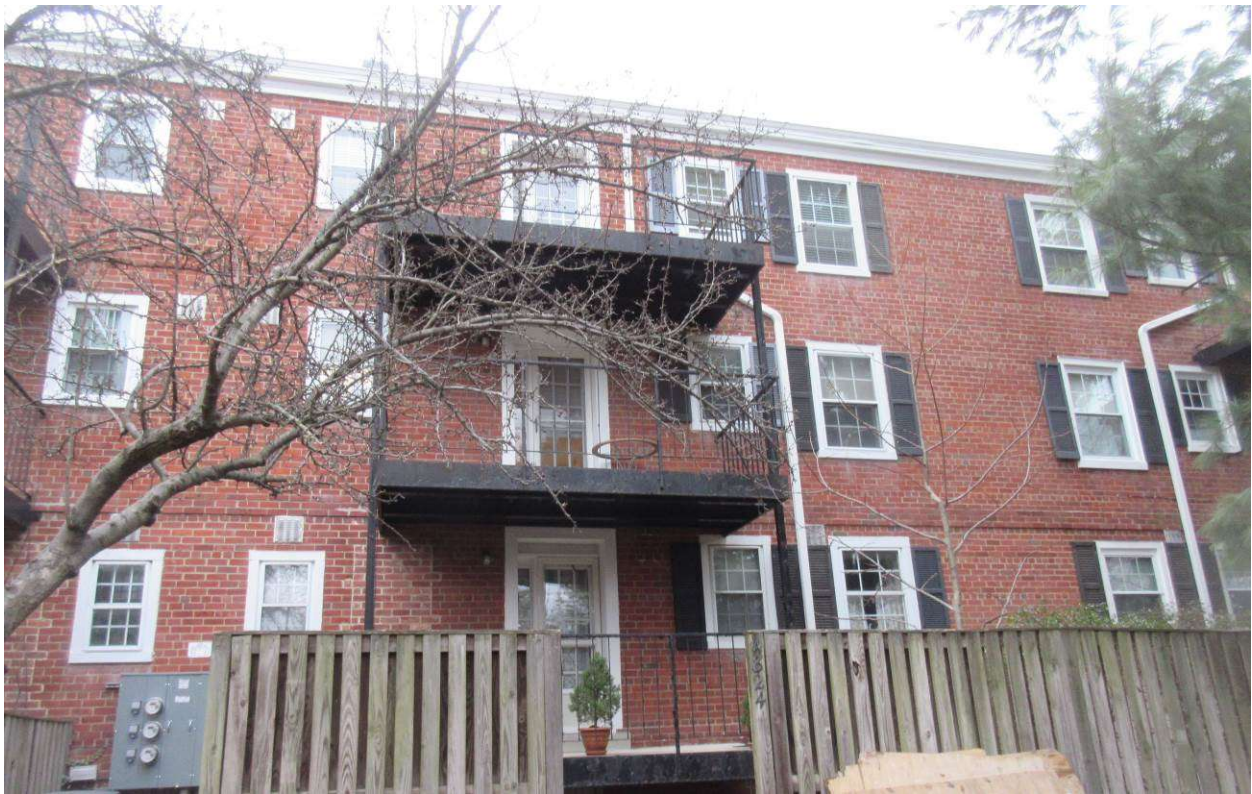
Overall view of steel framed balconies

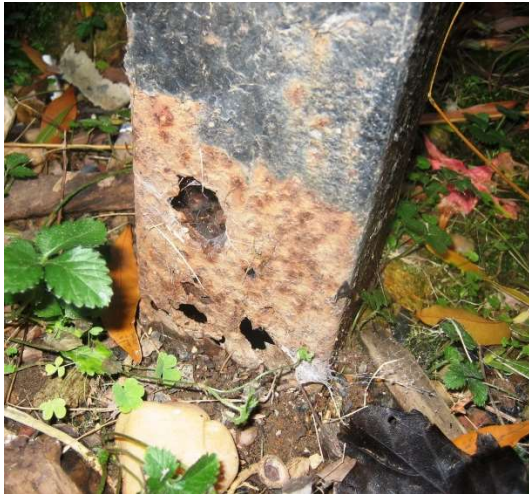
Corrosion of steel post base

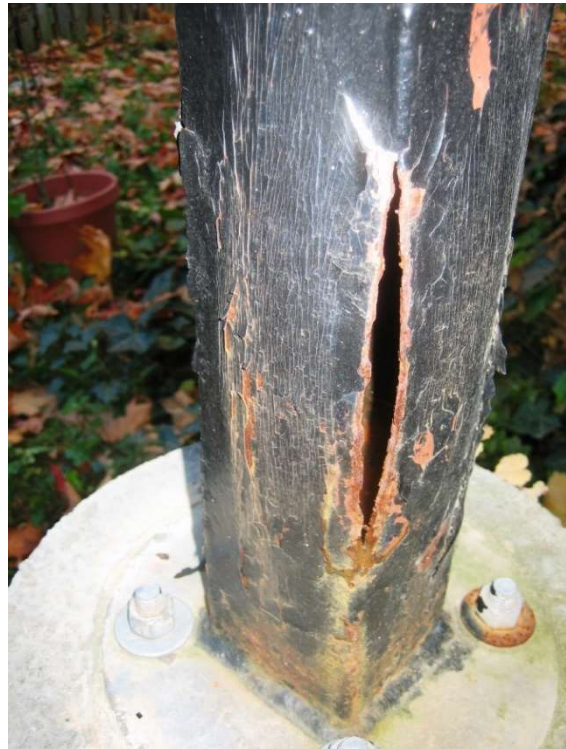
Corrosion of steel post base
