REPAIR AND PROTECTION OF STUCCO FACADE

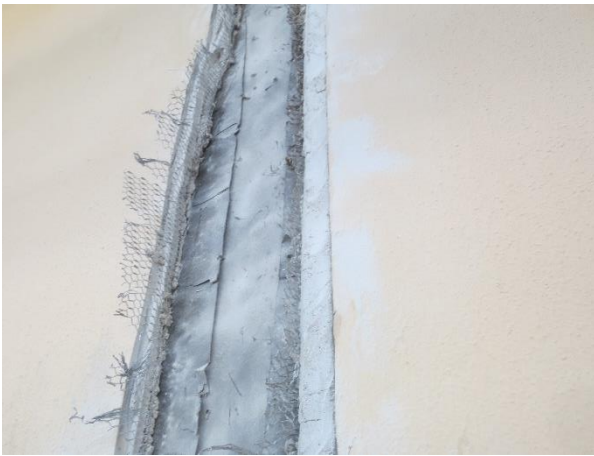
Deteriorated stucco removed from façade.

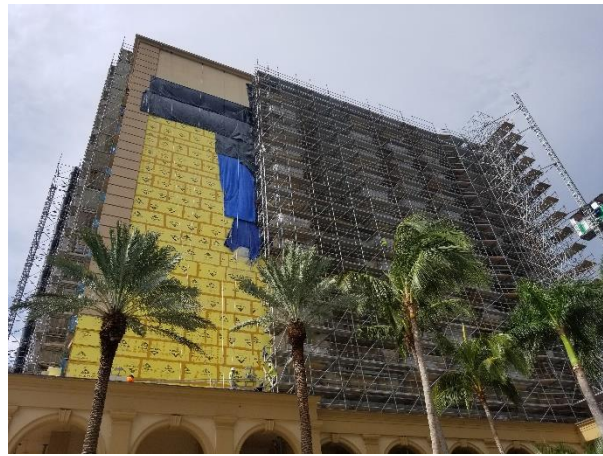
New wall sheathing placed after removal of stucco.

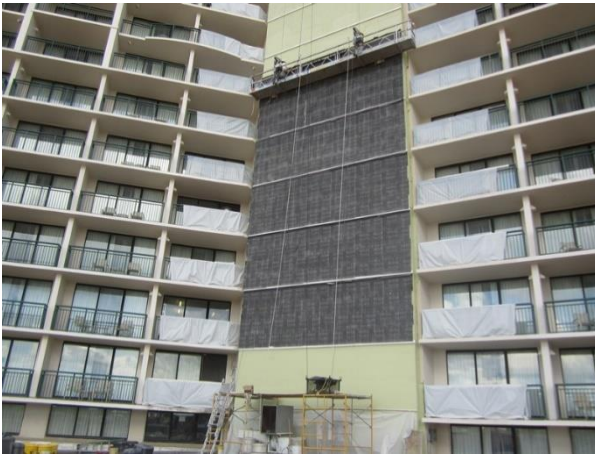
New lath and PVC accessories installed over new weather resistive barrier.

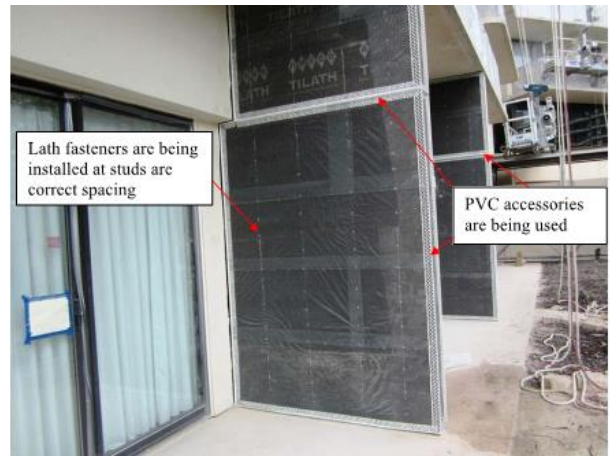
New lath and PVC accessories installed.

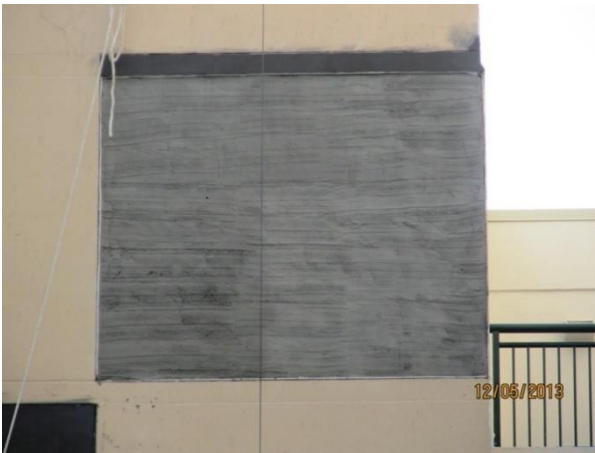
Scratch coat applied at a stucco repair area.

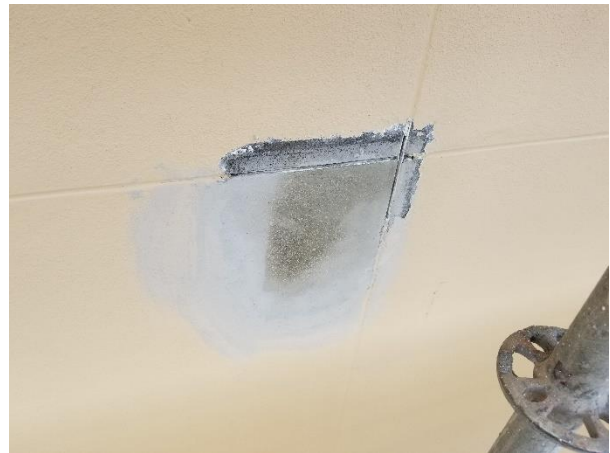
Stucco patch finished to match that of existing stucco.

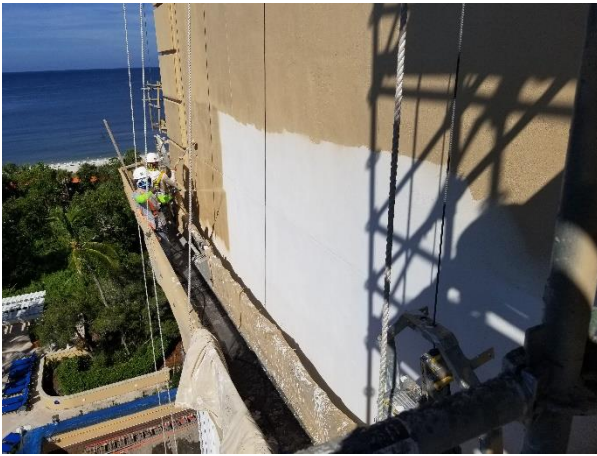
Application of primer and coating on repaired stucco wall.

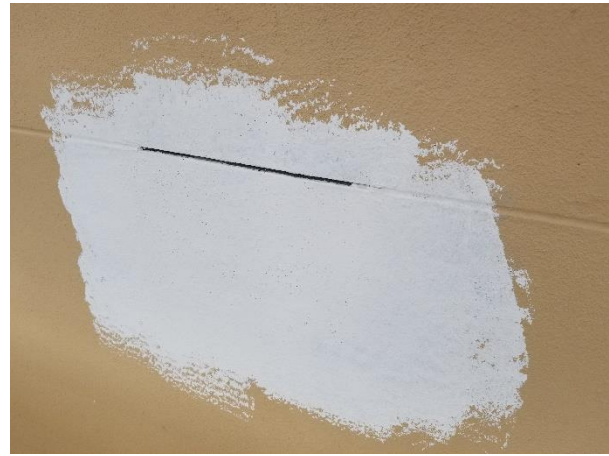
Application of primer on repaired stucco wall.
