INTRODUCTION TO FIBER CEMENT BOARD SIDING

INSTALLATION OF FIBER CEMENT BOARD SIDING

TYPICAL PROBLEMS WITH FIBER CEMENT BOARD SIDING

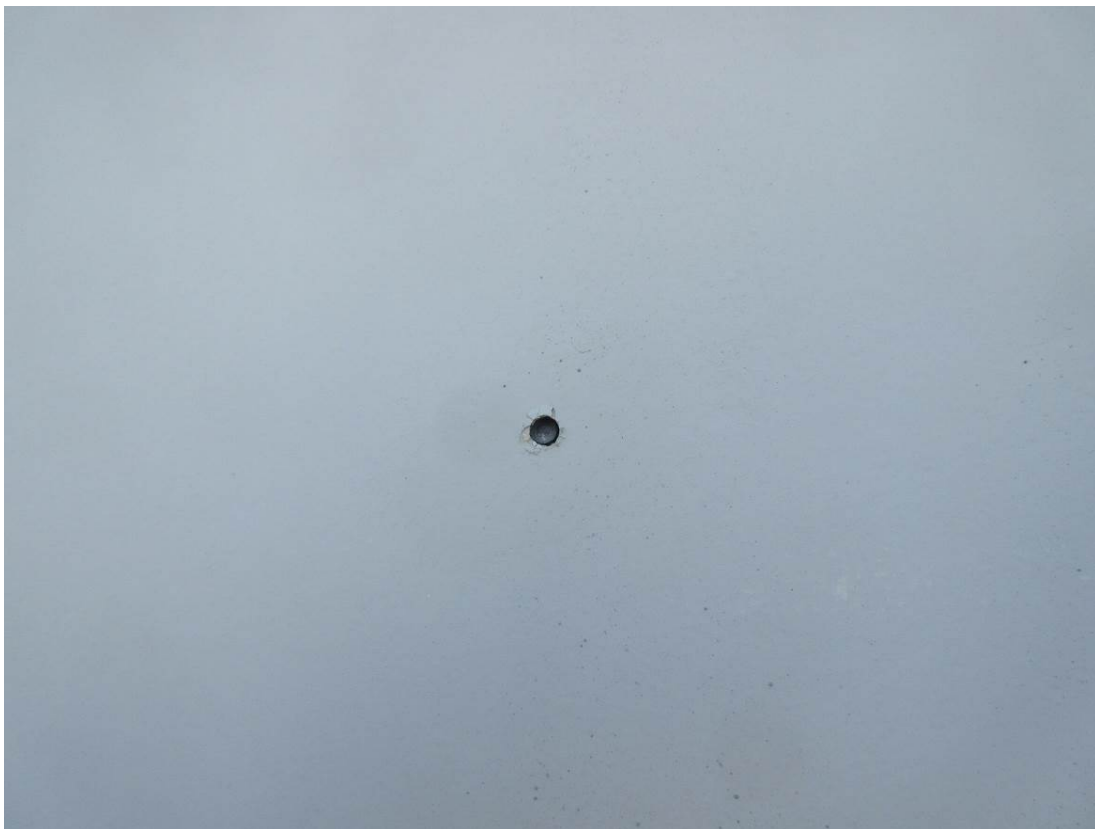
Typical overdriven fastener

1. Use of siding in a higher wind zone than allowed by manufacturer
2. Fasteners installed at spacing higher than that allowed by manufacturer
3. Fasteners installed that miss framing members
4. Overdriven fasteners
5. Fasteners installed too close to the edge of siding

Conditions #1 and #2 lead to increased load on each of the fasteners, which then cracks the siding when the loads are more than the siding can allow. Conditions #3 and #4 reduce the number of effective fasteners, which leads to increased load on each of the fasteners, which then cracks the siding when loads are more than the siding can allow. Condition #5 leads to cracking because there is insufficient fiber cement material surrounding the fastener to resist cracking.

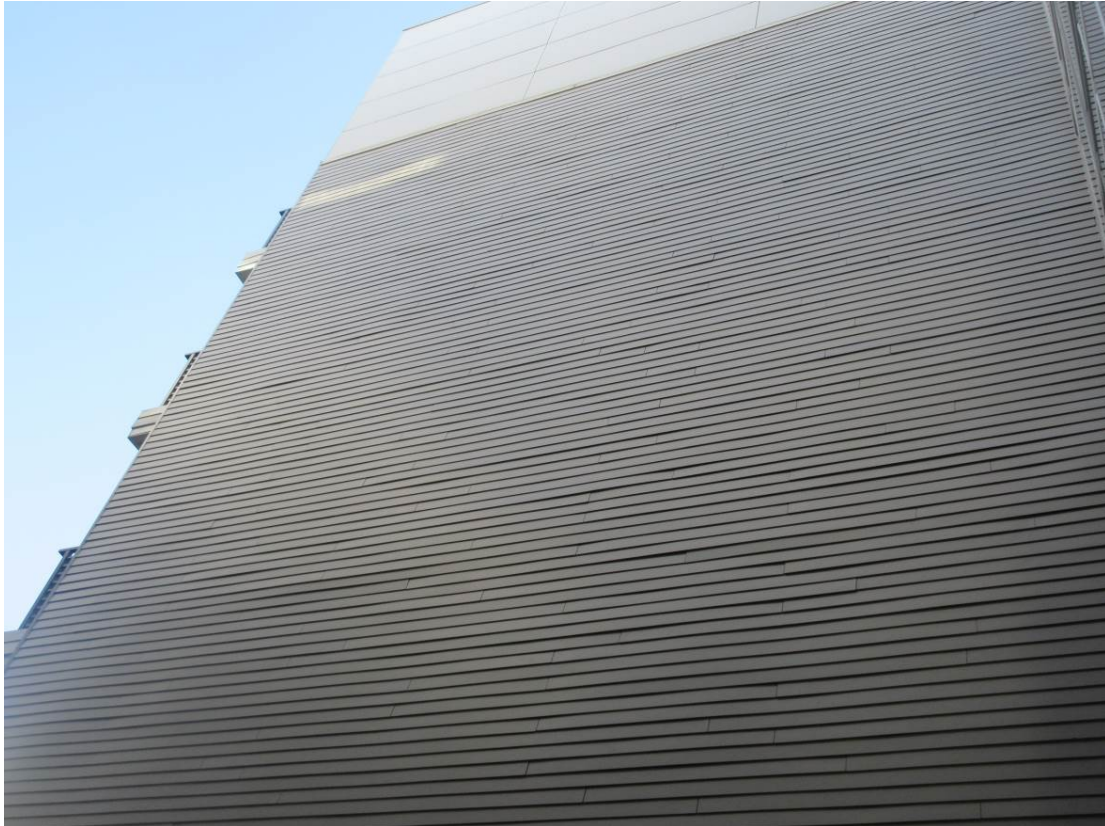
Waviness of fiber cement lap siding

Waviness and bulging of fiber cement siding is another common problem. Waviness and bulging can be caused by:

- Installation of a compressible drainage mat behind the siding in lieu of rigid furring
- Failed fasteners
- Fasteners installed at excessive spacing
- Fasteners installed that miss framing members
- Rot of sheathing behind siding
- Inadequate joints at edges of siding to allow for expansion

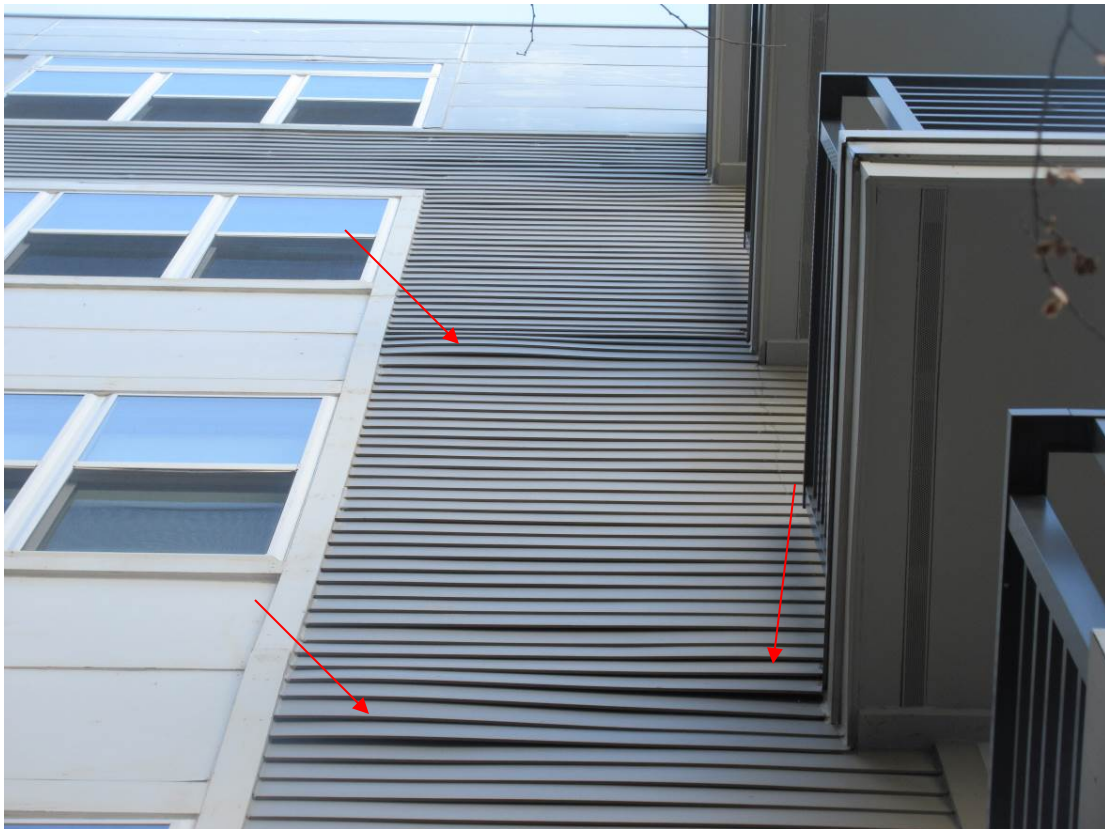
Significant bulging of fiber cement lap siding
